# Manhole Inspection Summary

Manhole # S13GG2019MH

**Location** Address: **5903 EASTCLIFF DR**

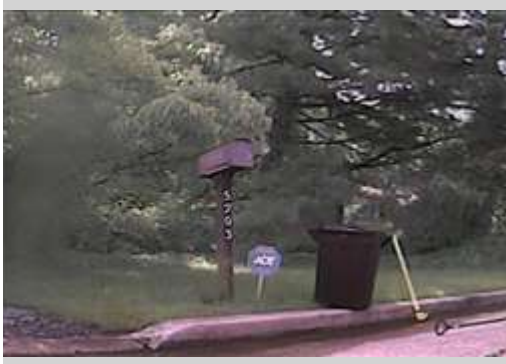
Location View

Comments **Cracks in pavement around manhole. Possible source of infiltration.**

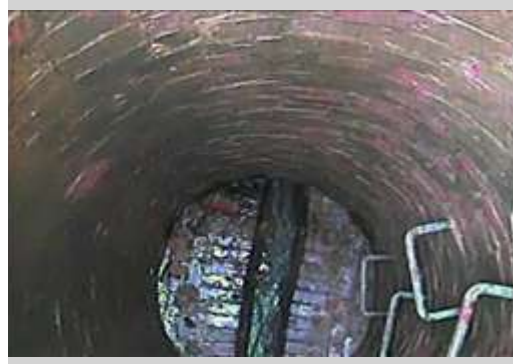
Top View

Bench debris.

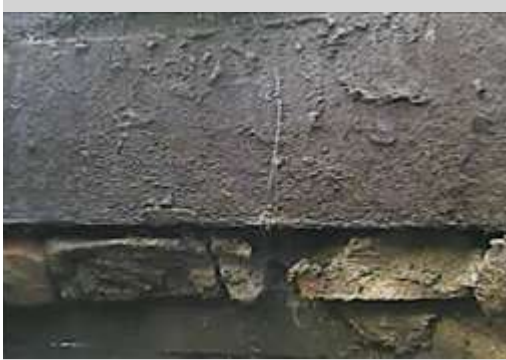
Defect

**Frame** Offset: **1.5** (in.) Condition: ☐ Sound ☐ Cracked ☒ **Leaks**

**Chimney / Frame Adjustment** ☒ Exists Material: **Brick and Concrete** ☐ Parged Height: **2** (in.)  
Condition: ☐ Sound ☐ Cracked ☐ Root Intrusion ☒ **Loose Brick** ☒ **Deteriorated**  
Infiltration: ☐ None ☒ **Joint** ☐ Cracks ☒ **Mortar** ☐ Roots ☐ Wall

Frame leaks. Adjustment deterioration, loose brick, and infiltration.

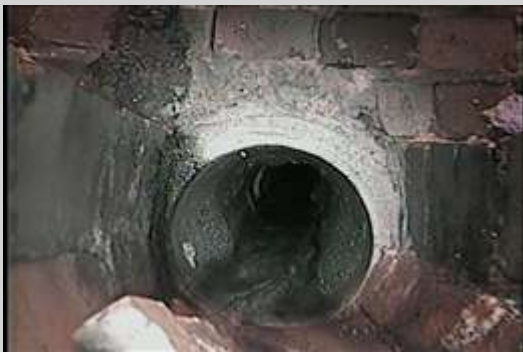
### 8 in. Circular Gravity Sewer Pipe Out @ 12 O'Clock

Deposits: ☐ None ☐ Mud ☐ Sludge ☐ Debris ☒ Grease

Silt Depth: **0** (in.) Deposits Extent: **Light**

Infiltration: **Evidence** Pipe Seal Cond: **Unknown**

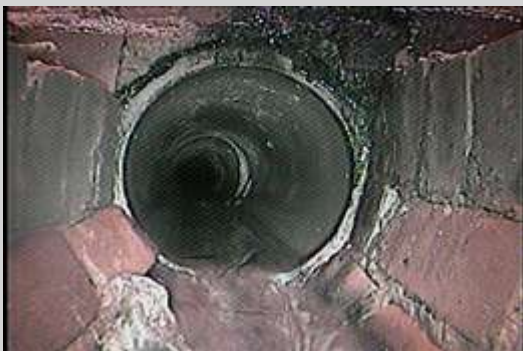
### 8 in. Circular Gravity Sewer Pipe In @ 6 O'Clock

Infiltration: **Evidence** Pipe Seal Cond: **Unknown**
